Geology of the Spring Creek Watershed

2015 State of the Water Resources Report

Water Resources Monitoring Project

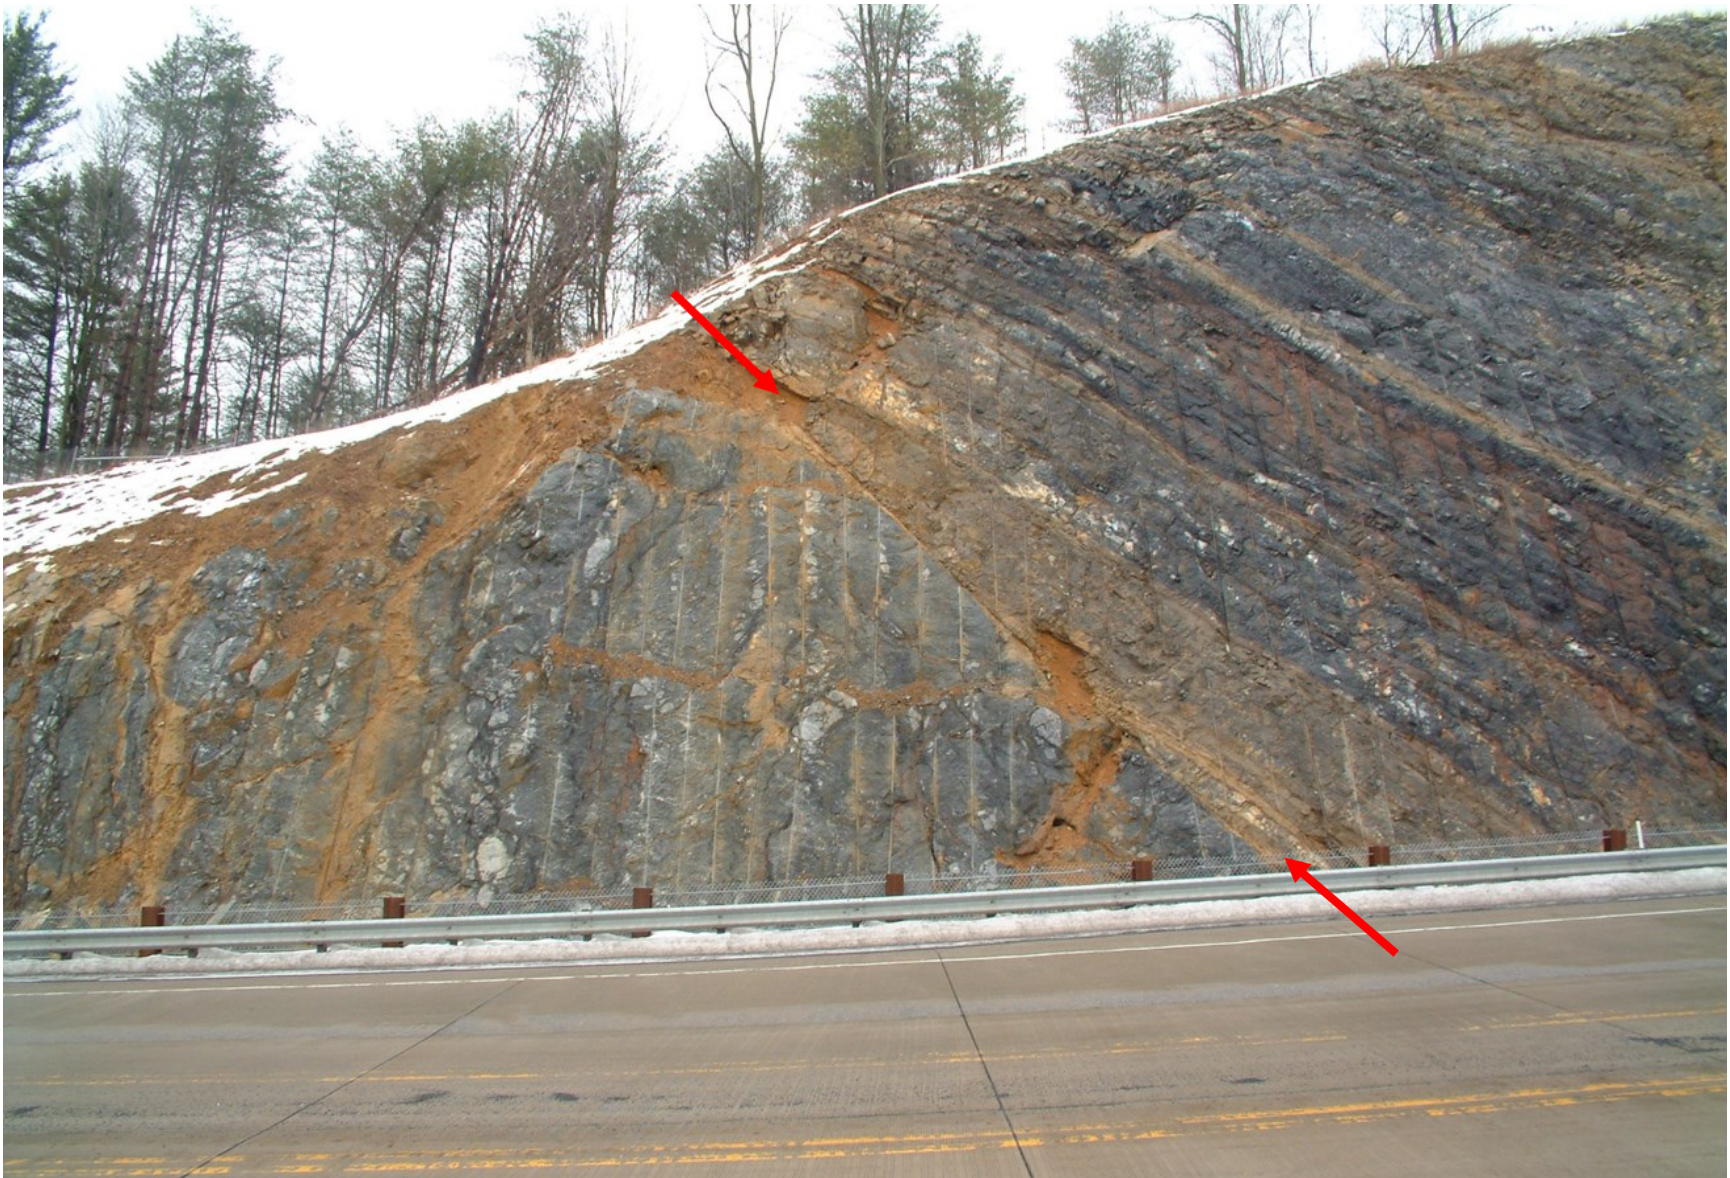
The Birmingham Thrust Fault (indicated in red) in the bedrock exposed along Skytop Mountain Road in Patton Township (T. Giddings).

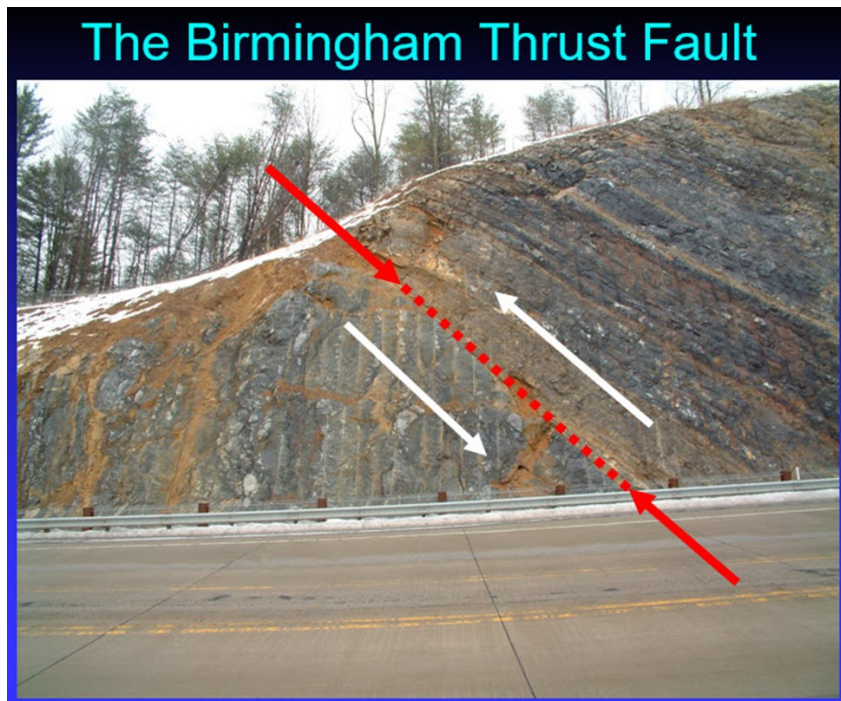
Figure 7. The Birmingham thrust fault along Skytop Road (T. Giddings).

Over eons of geologic time, slightly acidic rainfall and snowmelt water became groundwater recharge, and this groundwater dissolved the ground-up bedrock along the fault plane at a faster rate than the adjacent intact bedrock. Today large open solution conduits that formed along the fault plane below the water table provide a preferential groundwater flow path to the pool of the Big Spring in Bellefonte. **Figure 8** shows an example of a very large

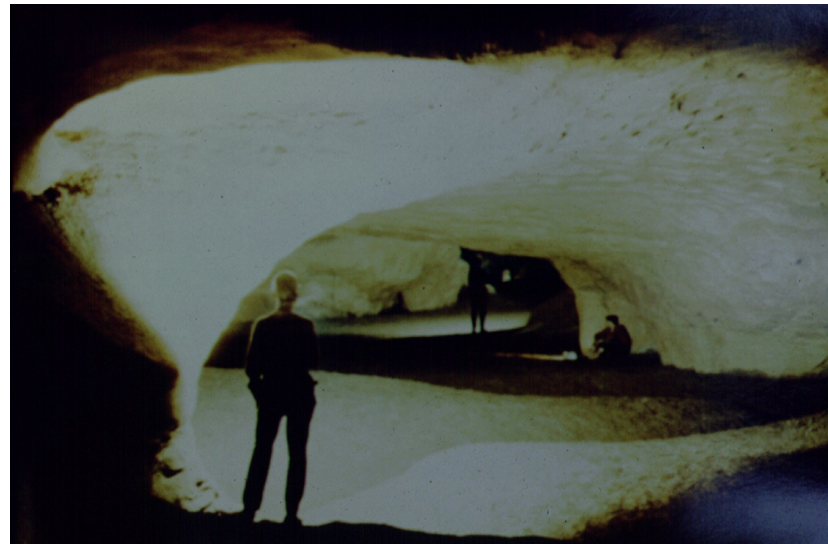
Figure 8. A typical large, dry solution conduit similar to those found along the Birmingham Thrust Fault (T. Giddings).

solution conduit similar to those that would be found along the plane of the Birmingham Thrust Fault. The ease of groundwater flow to the Big Spring through the open solution conduits is the cause of the groundwater piracy from beneath the Spruce Creek surface-water watershed. The groundwater flow is taking the path-of-least-resistance to the Big Spring, some 15 miles to the northeast of the headwaters recharge area around and including State Game Lands 176. **Figure 9** shows an oblique view of the groundwater boundary for the Spring Creek watershed. Each red double circle represents a municipal water-supply

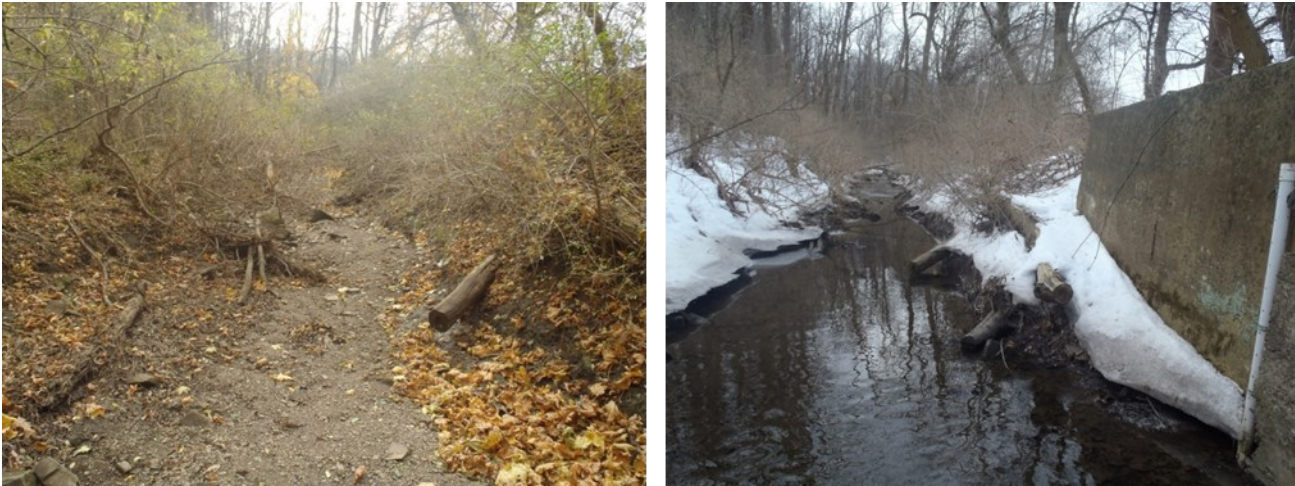
Figure 11. Walnut Run in fall 2014 (left) and during fall 2015 (right).

follows the natural flow path to the saturated zone and the stream disappears underground. For this reason, stream reaches of Buffalo Run, Slab Cabin, Upper Spring Creek, and Walnut Run often go dry during summer months, losing water to the underground karst system where it will later emerge downstream as spring water or baseflow. We can view this trend from pictures of Walnut Run during extreme drought, and during normal baseflow conditions (**Figure 11**).

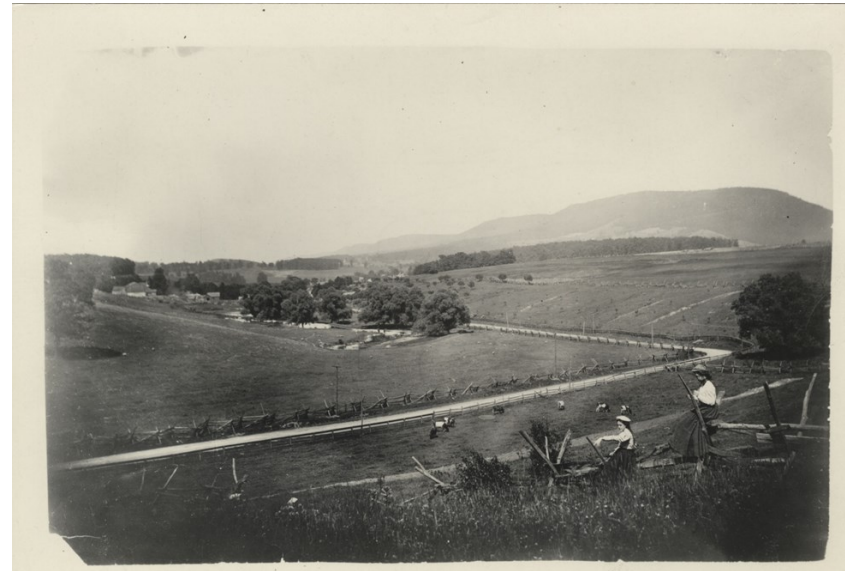
Figure 14. Photograph of Thompson Spring in the Late 1890s showing the current Location of Penn State Wastewater Treatment Plant.

Urbanization often results in the construction of impervious surfaces resulting in higher rates or surface runoff, more frequent surface runoff events, degraded water quality, altered stream temperatures, stream channel instability and erosion, loss of aquatic habitat, and a loss of stream baseflow. One local example of these impacts can be seen in **Figure 14**, which shows the headwater of Thompson

Run in the 1890s with no evidence of frequent surface water runoff occurring, such as channeling. Today, an inflow channel to the “duck pond” at the head of Thompson Run is apparent. This feature is approximately 15 ft wide and 3 ft deep and is derived from erosion below State College's storm drain outfall pipes. Surface water quality in Thompson Run, in response to precipitation events, has also degraded, and downstream nuisance flooding occurs frequently. Although the duck pond is known to have an adverse thermal impact on Thompson Run, it is an effective sediment removal feature.

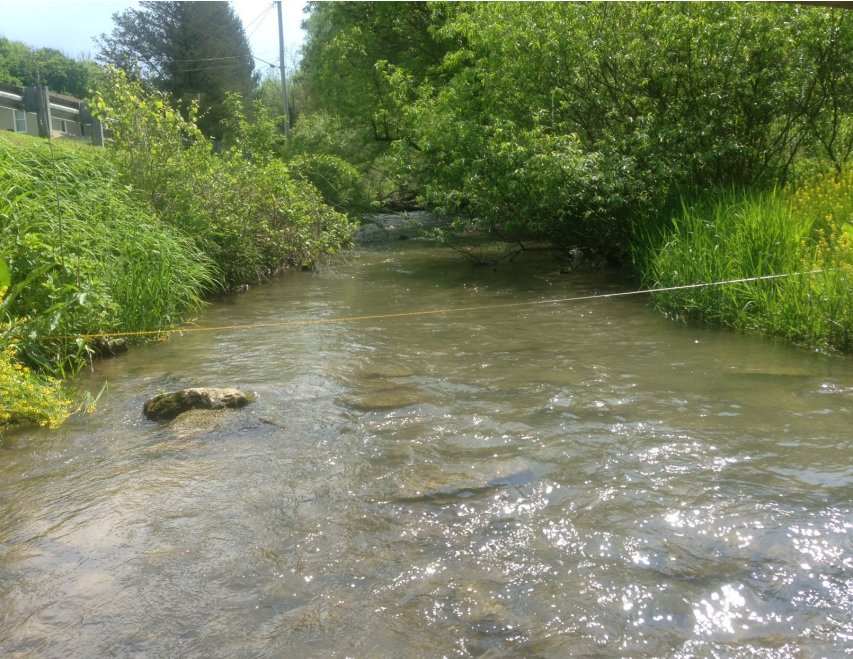
The WRMP rating curve transect location at Lower Buffalo Run.

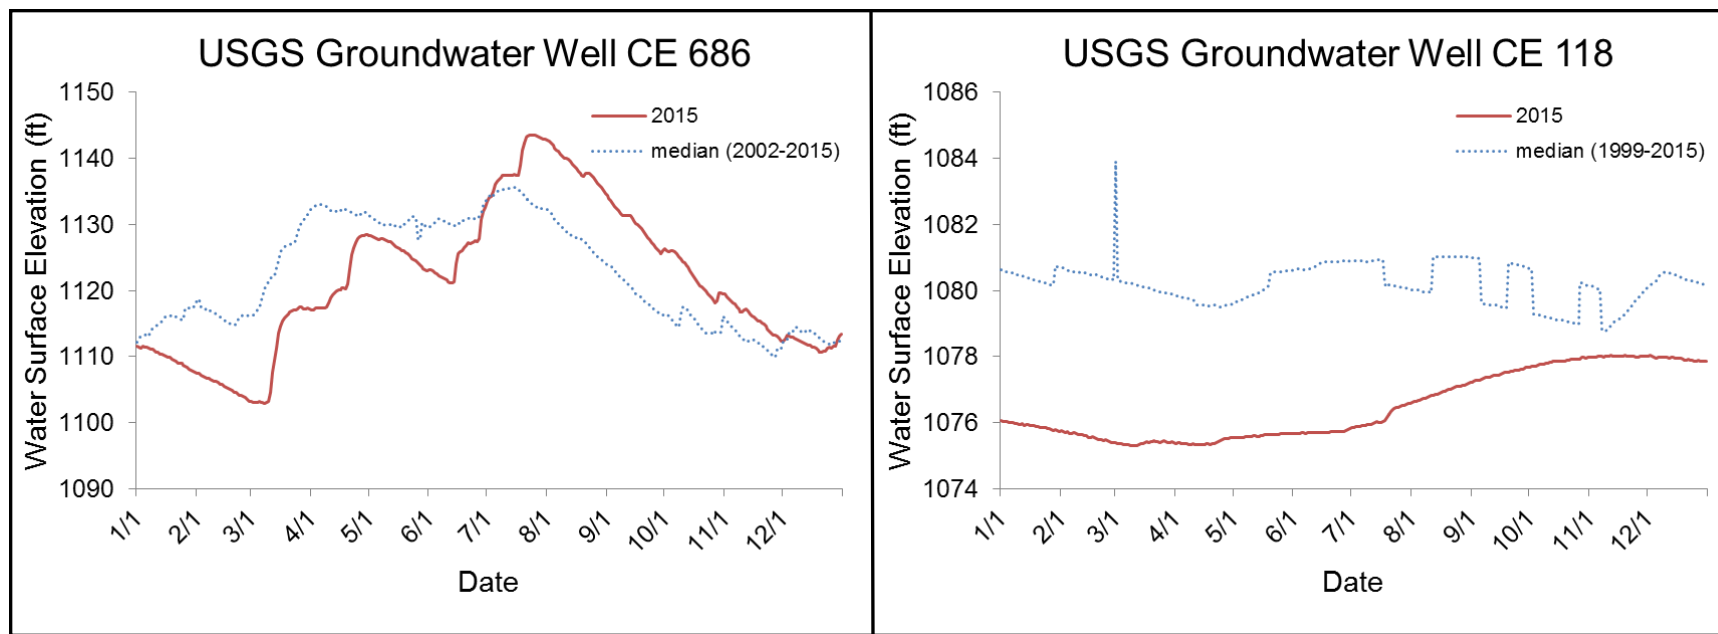
Appendix 8: Daily Groundwater Elevations for 2015 (*continued*)

Water elevation data from the U.S. Geological Service. Downloaded from <http://waterdata.usgs.gov/nwis/rt>.
